**Field Oversight Summary  
Materials Handling Treatability Study  
American Chemical Services, Inc.**

**July 1997**

USEPA Region 5  
American Chemical Services  
Field Oversight  
Materials Handling Treatability Study

BVSPC Project 71670  
BVSPC File D.3  
August 28, 1997

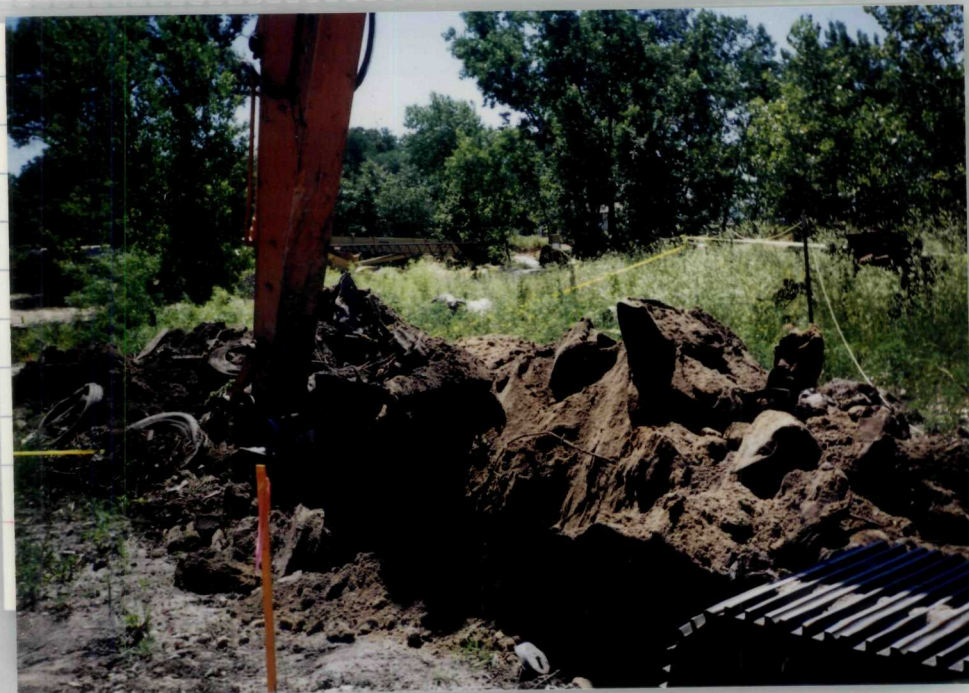
Site: American Chemical Services, Inc. RD/ERA  
 Project: 71670  
 Photo: 2  
 Date: 7/16/97 Time: 1115  
 Photographer: Steve Mrkvicka  
 Description: Looking east at Trench No. 1 located due east of SA03.  
 Crushed drums and dirt in pit. Strong solvent odor.

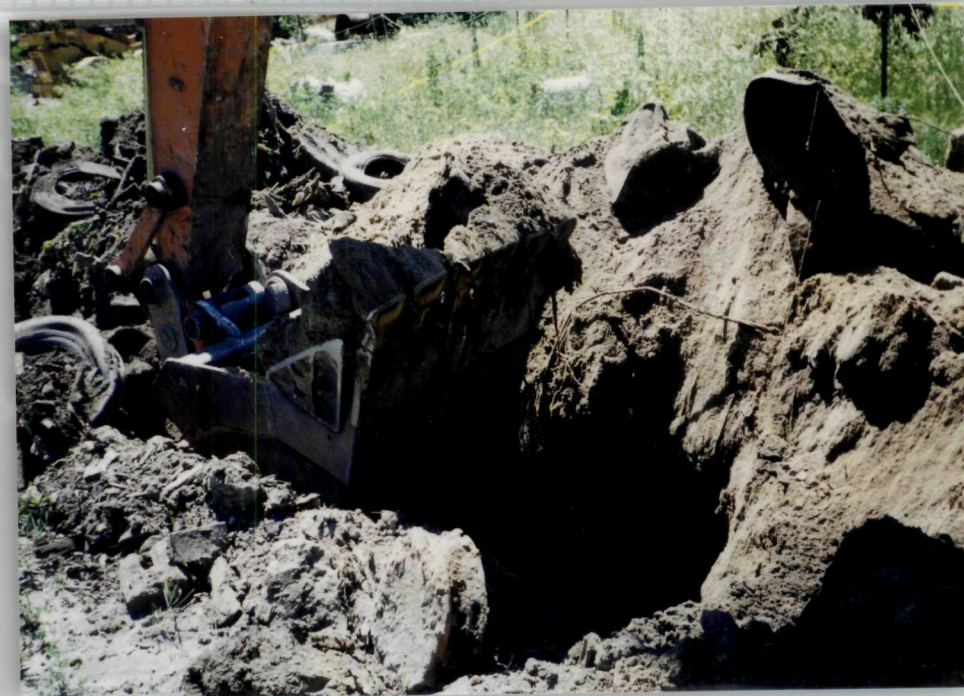
Site: American Chemical Services, Inc. RD/ERA  
 Project: 71670  
 Photo: 1  
 Date: 7/16/97 Time: 1115  
 Photographer: Steve Mrkvicka  
 Description: Looking east at Trench No. 1 located due east of SA03.  
 Crushed drums and dirt in pit. Strong solvent odor.

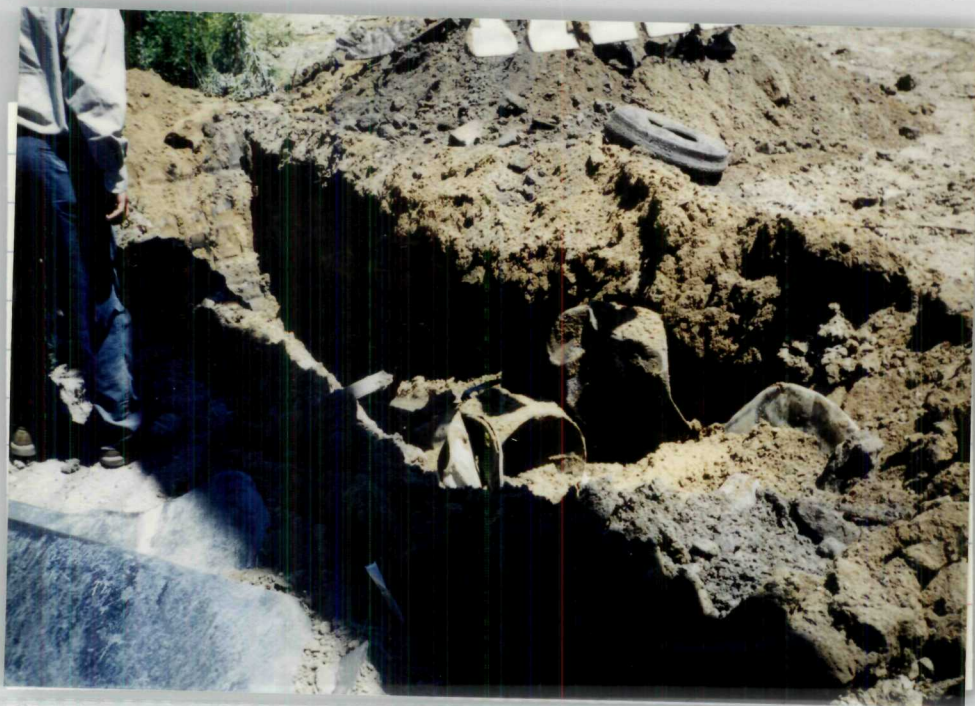
Photo: 4

Description: Looking northeast at Trench No. 3 located about 50 feet west of SA04. Drums found at 4 feet below ground surface and soil with solvent smell. Depth of drums slope downward toward the north. Encountered liquid that is bubbling.

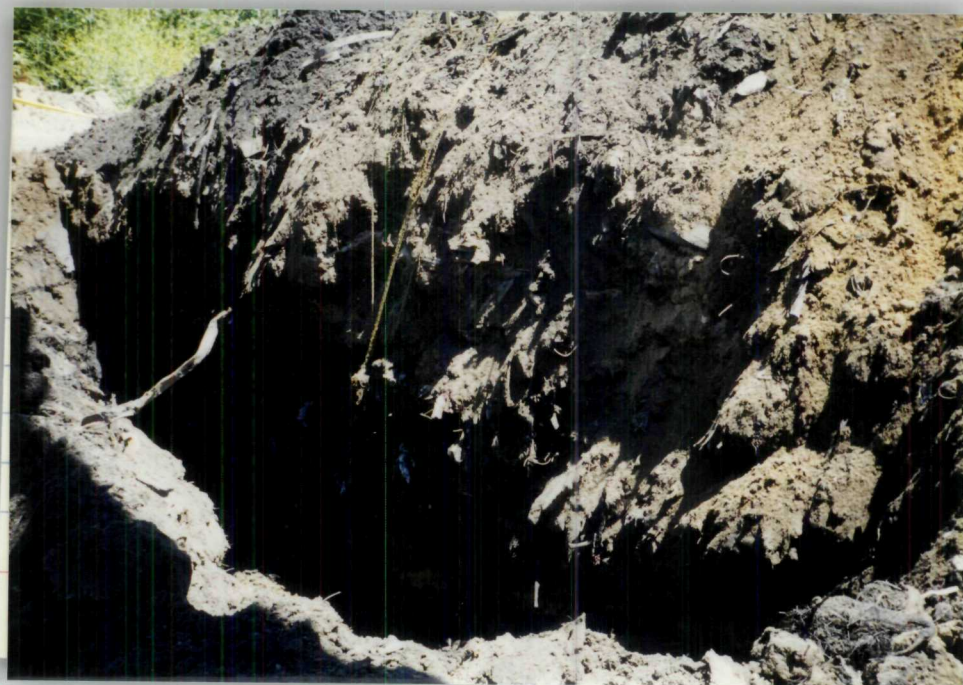
Photo: 3

Description: Looking northeast at Trench No. 2 located north of SA03. Trench is about 6 feet deep. No drums discovered. Large amount of debris mixed with soil and sand.

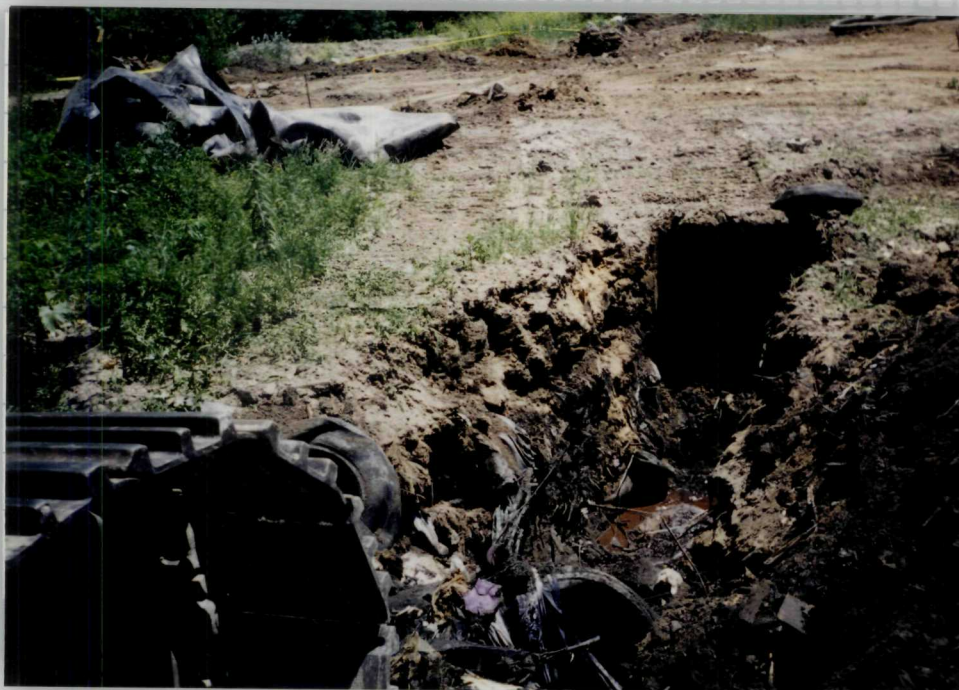
Photo: 6

Description: Looking east into Trench No. 4 located about 100 feet west of SA03. Encountered large amount of stained debris (tires, metal, etc.) mixed with soil (black-brown dirt). Hit drums and liquid at about 4 feet below ground surface.

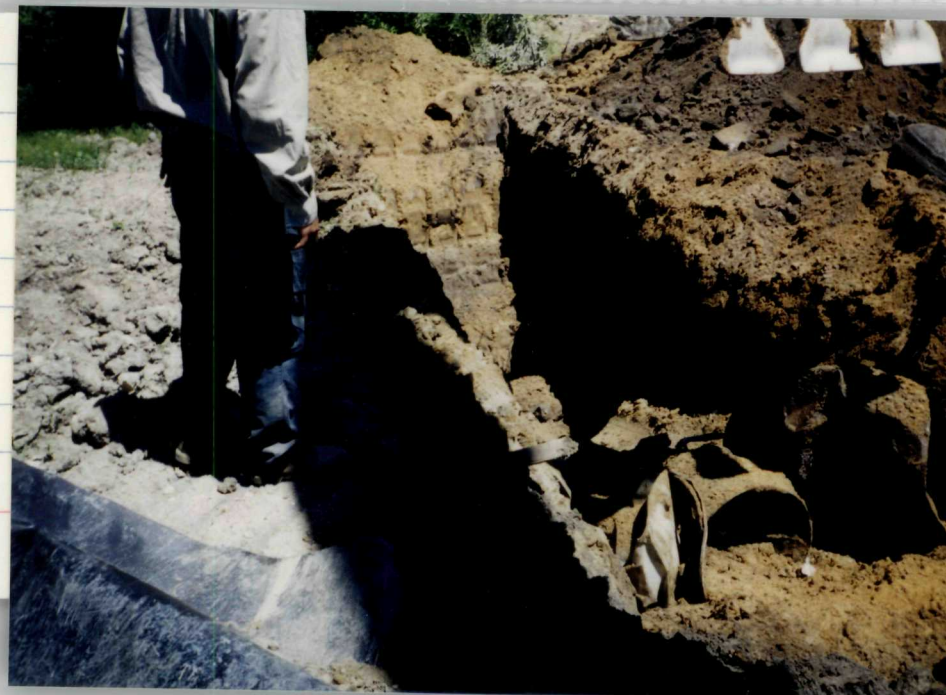
Photo: 5

Description: Looking northeast at Trench No. 3 located about 50 feet west of SA04. Drums found at 4 feet below ground surface and soil with solvent smell. Depth of drums slope downward toward the north. Encountered liquid that is bubbling.

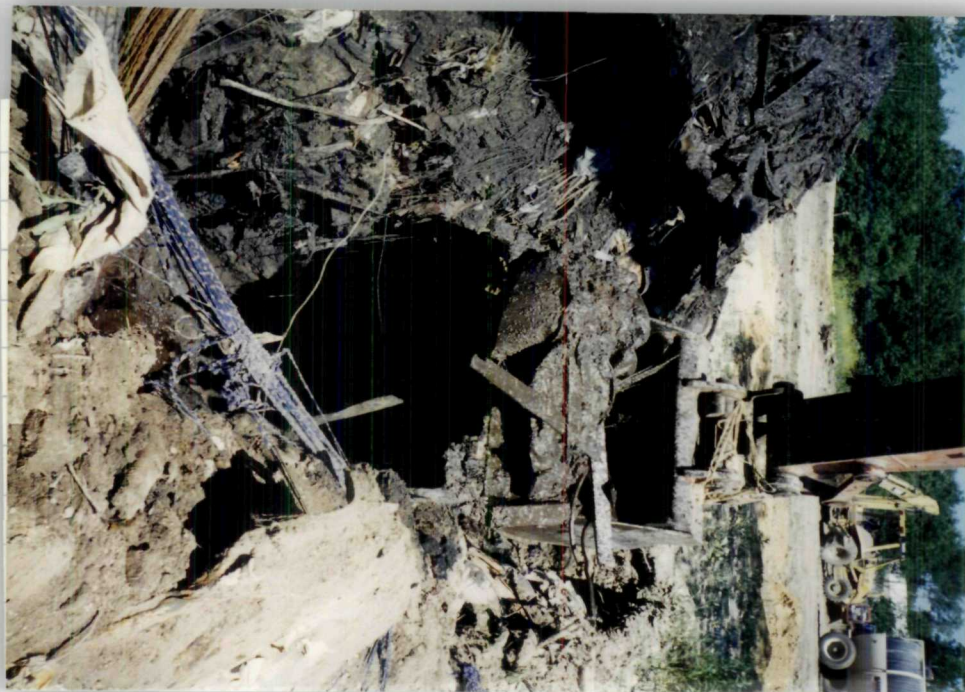
Photo: 8

Description: Looking northeast at Trench No. 5 located about 100 feet northeast of SA05. Drum hanging from bucket of backhoe. Drums in the trench. Encountered liquid and drums at about 10 feet below ground surface. Strong petroleum smell.

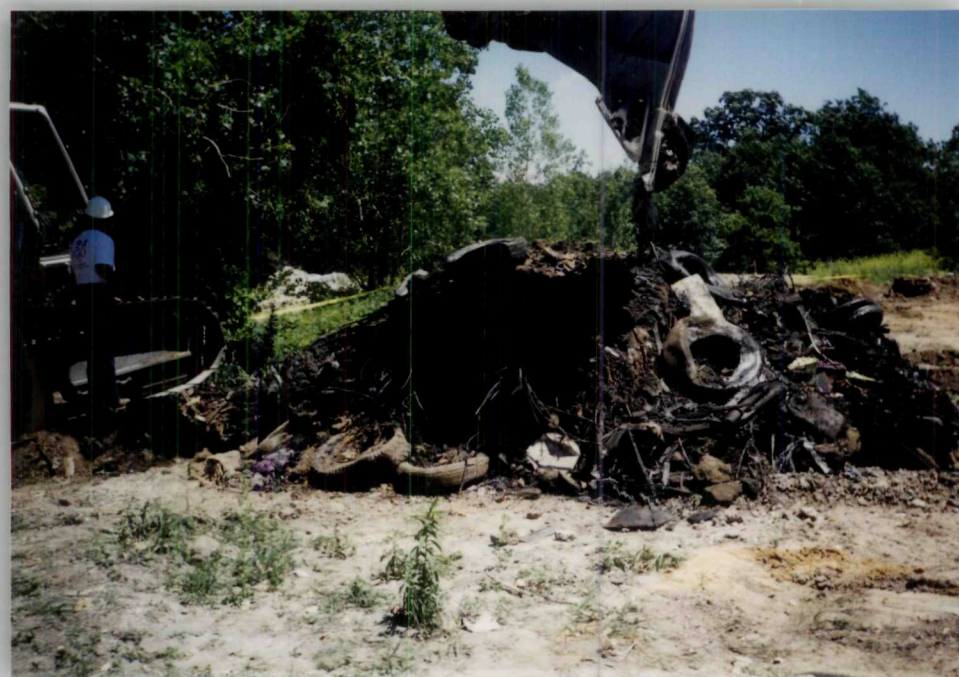
Photo: 7

Description: Looking east at debris pile from Trench No. 4 located about 100 feet west of SA03. Encountered large amount of stained debris (tires, metal, etc.) mixed with soil (black-brown dirt). Hit drums and liquid at about 4 feet below ground surface.

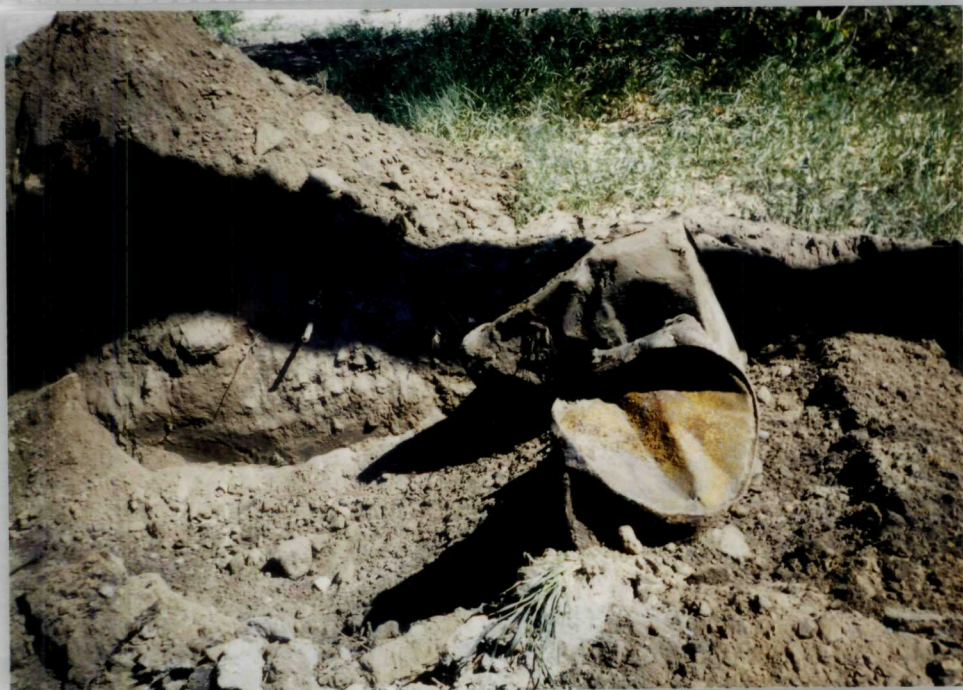
Photo: 10

Description: Looking southeast at Trench No. 6 located southwest of SA01. Drums found at about 18 inches below ground surface. Drums are leaking clear and purple liquid.

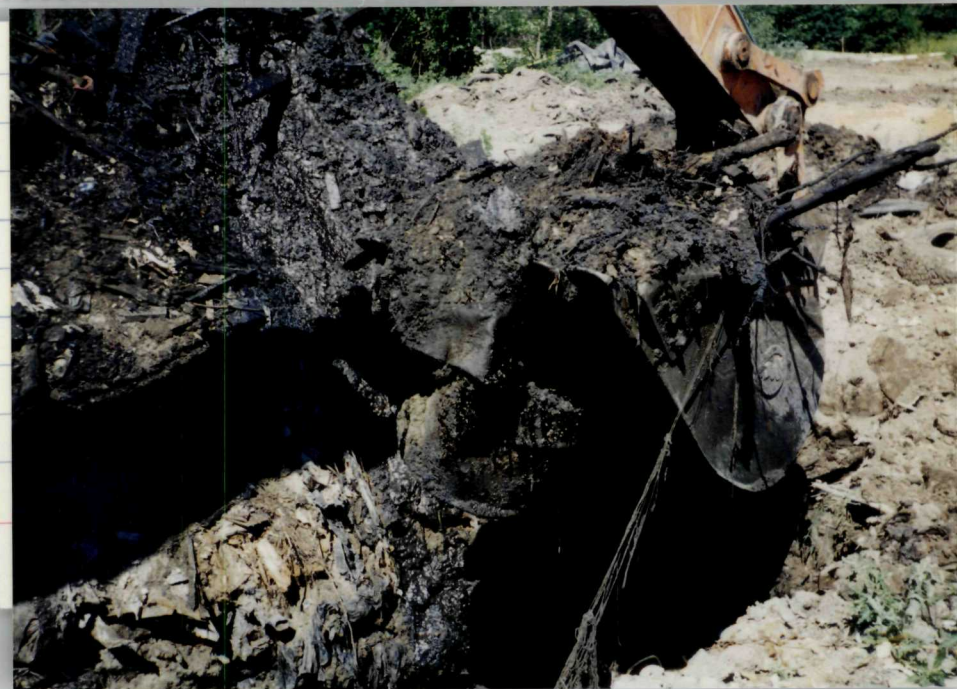
Photo: 9

Description: Looking east at Trench No. 5 located about 100 feet northeast of SA05. Drum hanging from bucket of backhoe. Drum is leaking clear liquid into excavation.

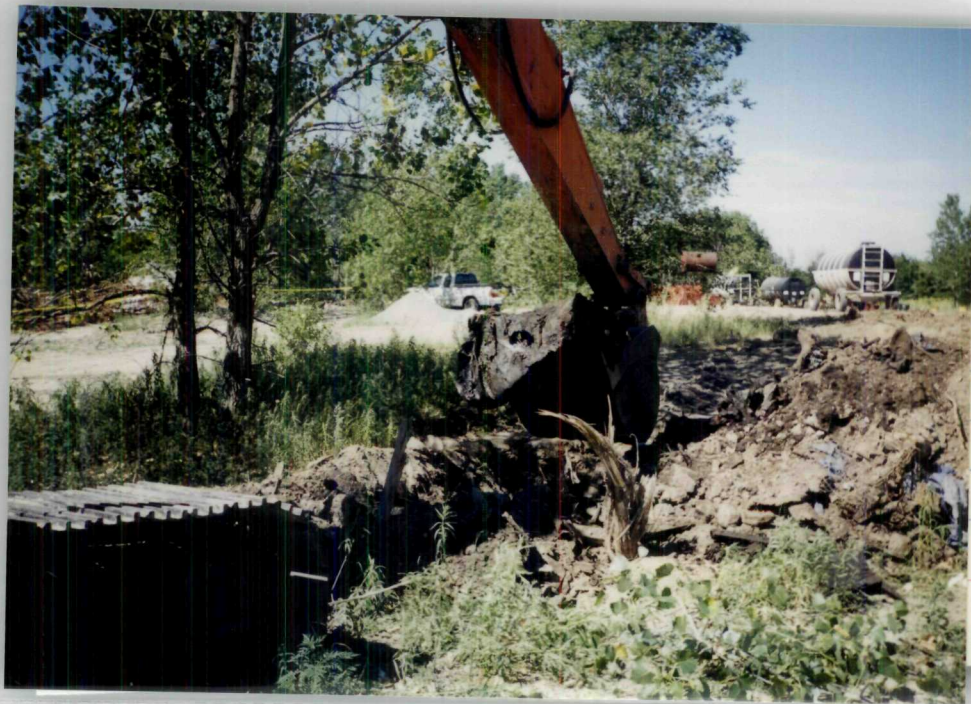
Site: American Chemical Services, Inc. RD/ERA  
 Project: 71670  
 Photo: 12  
 Date: 7/16/97 Time: 1530  
 Photographer: Steve Mrkvicka  
 Description: Eastward from Trench No. 6. Looking north at drum hanging from bucket. Excavated to about 8 feet below ground surface.

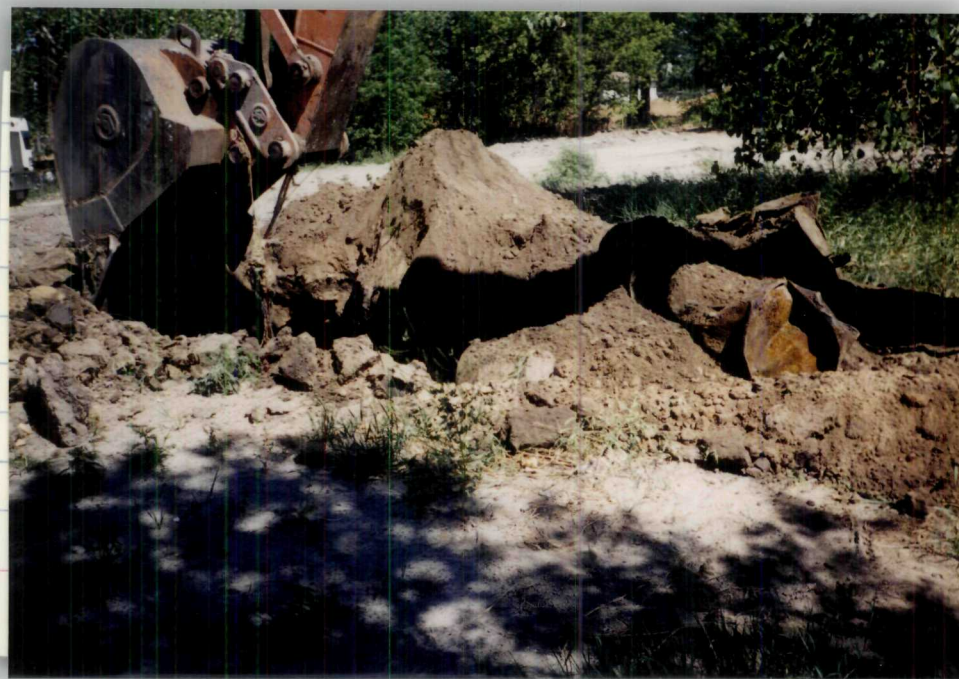
Site: American Chemical Services, Inc. RD/ERA  
 Project: 71670  
 Photo: 11  
 Date: 7/16/97 Time: 1530  
 Photographer: Steve Mrkvicka  
 Description: Looking southeast at Trench No. 6 located southwest of SA01. Drums found at about 18 inches below ground surface. Drums are leaking clear and purple liquid.

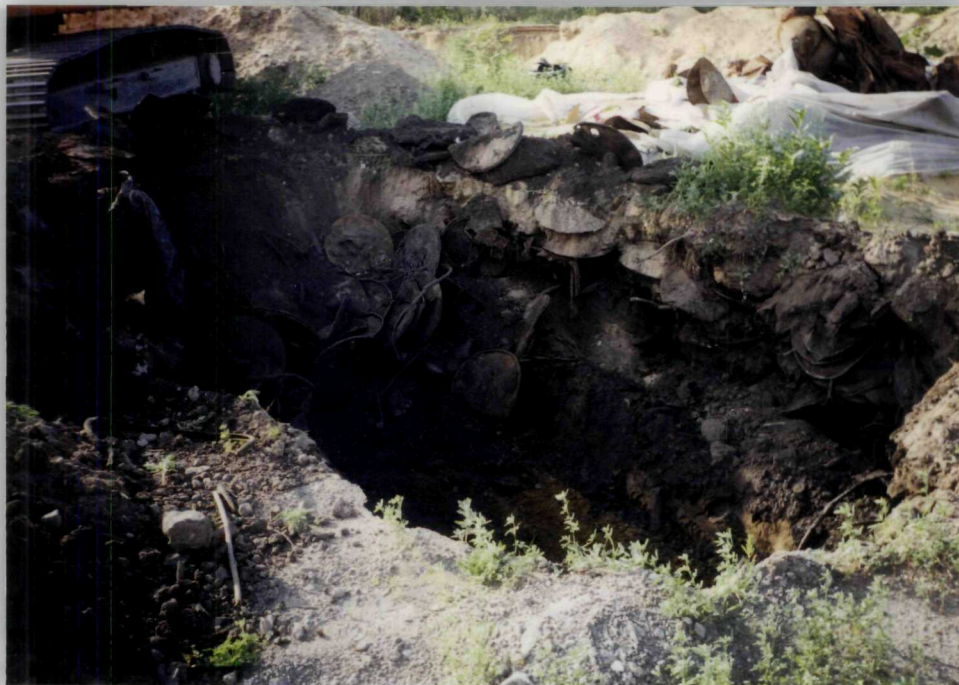
Site: American Chemical Services, Inc. RD/ERA  
 Project: 71670  
 Photo: 14  
 Date: 7/17/97 Time: 0750  
 Photographer: Steve Mrkvicka  
 Description: Looking east into KP01, which is located near the former Kapica-Pazmey building. Layers of crushed drums. Strong solvent smell. Mixed with dark soil.

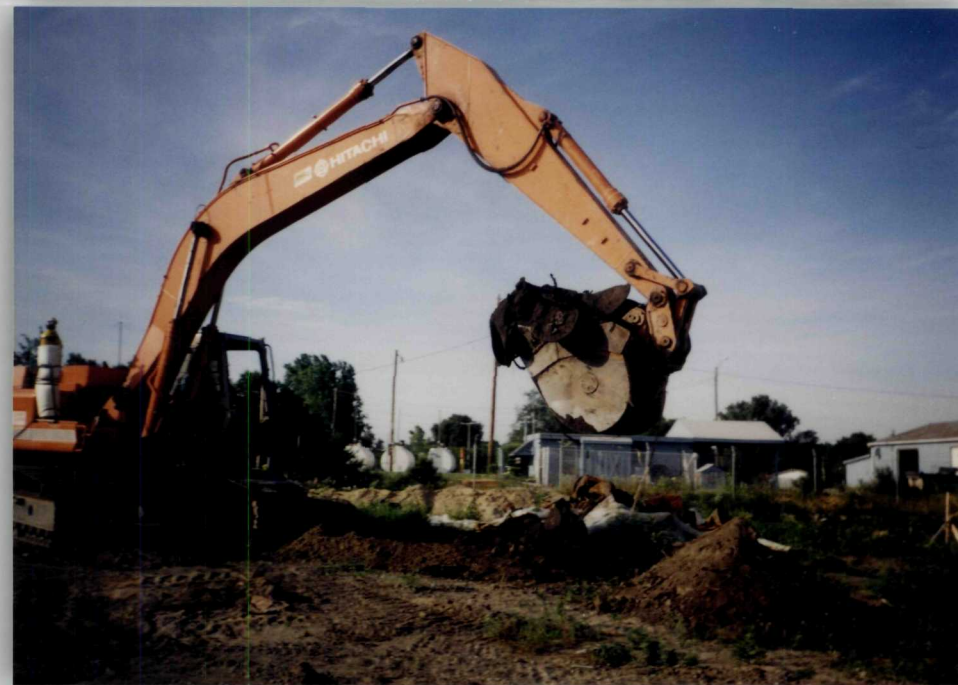
Site: American Chemical Services, Inc. RD/ERA  
 Project: 71670  
 Photo: 13  
 Date: 7/17/97 Time: 0750  
 Photographer: Steve Mrkvicka  
 Description: Looking south at pit KP01, which is located near the former Kapica-Pazmey building. Numerous drum carcasses. Strong solvent smell. Large amount of soil mixed with drums.

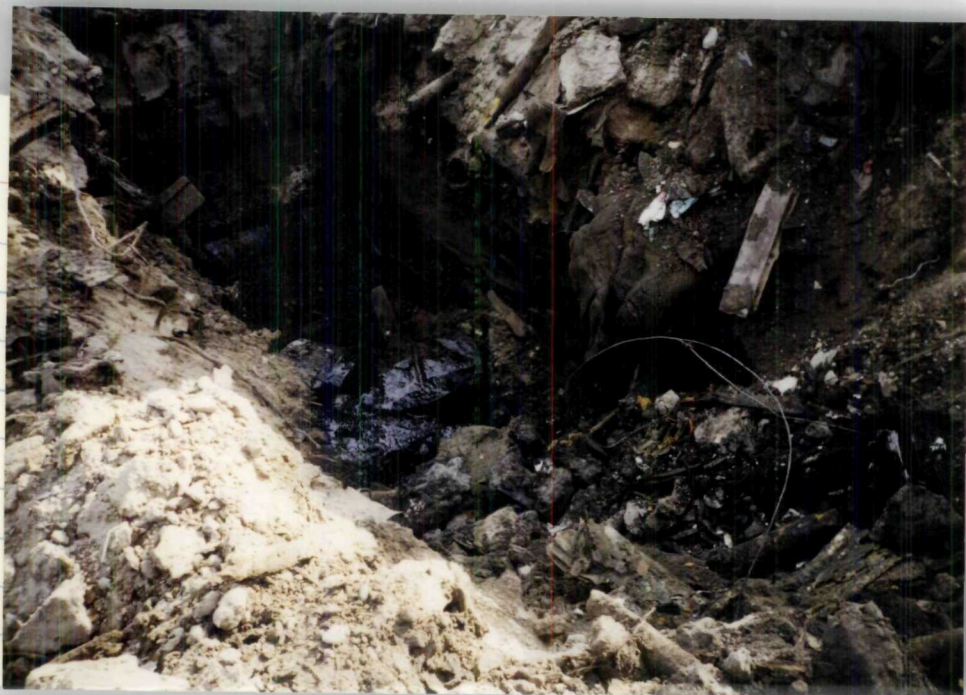
Site: American Chemical Services, Inc. RD/ERA  
 Project: 71670  
 Photo: 16  
 Date: 7/17/97 Time: 0855  
 Photographer: Steve Mrkvicka  
 Description: Looking northeast into Trench No. 8. Drums  
 encountered at about 6 feet below ground surface.

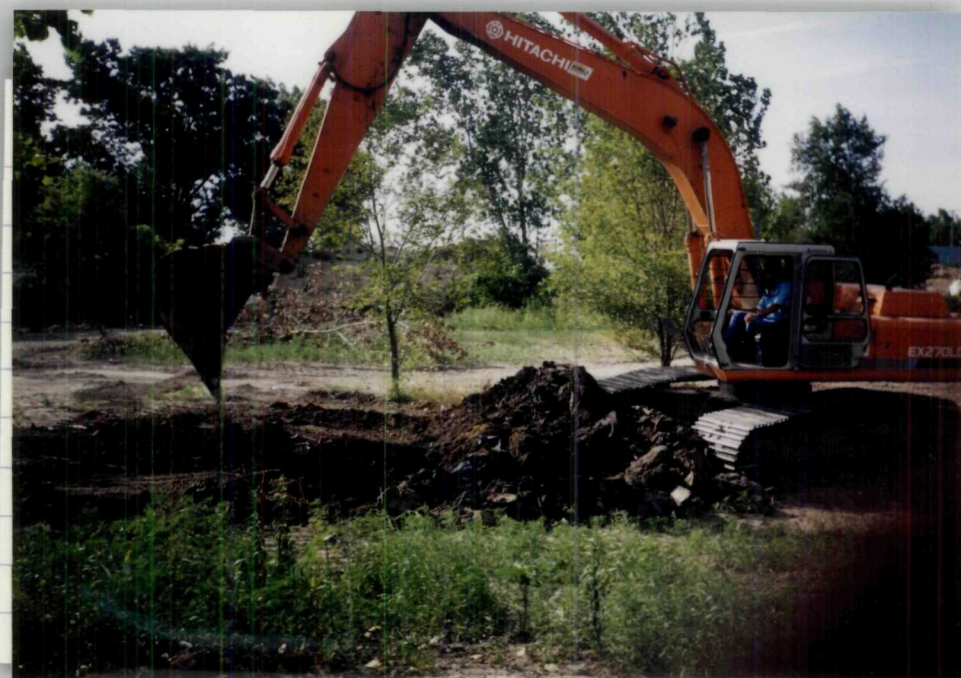
Site: American Chemical Services, Inc. RD/ERA  
 Project: 71670  
 Photo: 15  
 Date: 7/17/97 Time: 0845  
 Photographer: Steve Mrkvicka  
 Description: Looking southeast at backfilling of Trench No. 7 located  
 along southern side of SA01.

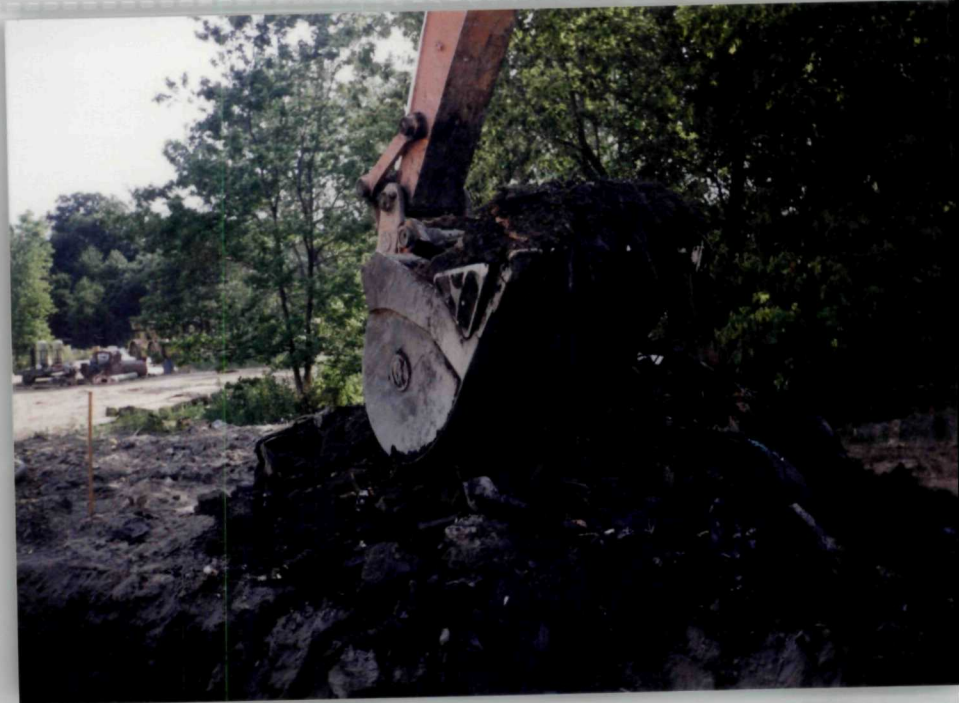
Site: American Chemical Services, Inc. RD/ERA  
 Project: 71670  
 Photo: 17  
 Date: 7/17/97 Time: 0855  
 Photographer: Steve Mrkvicka  
 Description: Looking northeast into Trench No. 8. Drums encountered at about 6 feet below ground surface.

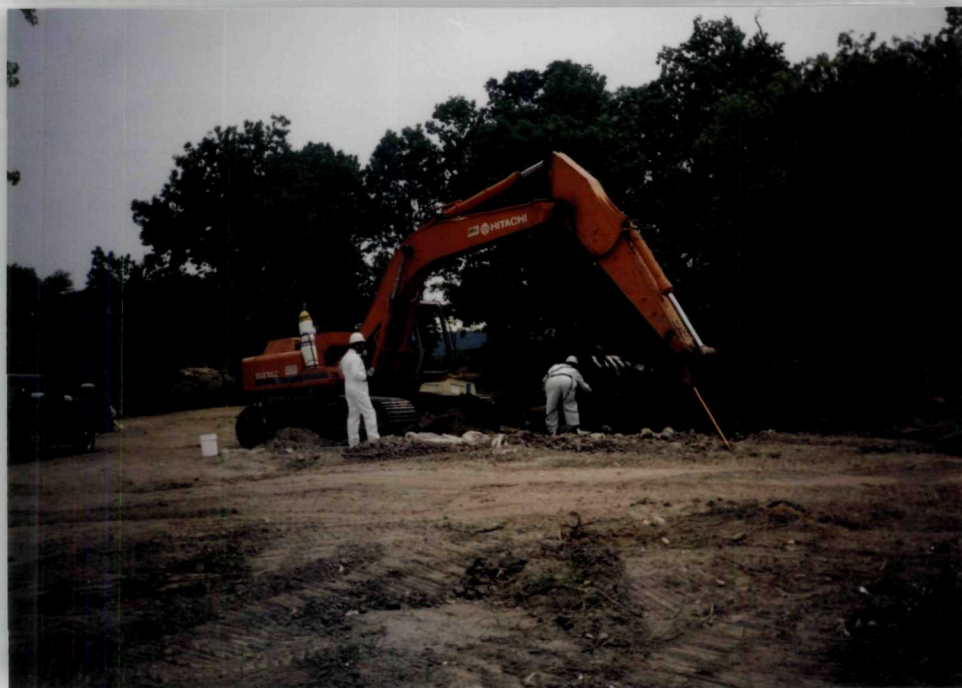
Photo: 22

Description: Looking east. Sampling crew is collecting a liquid sample from SA02 pit.

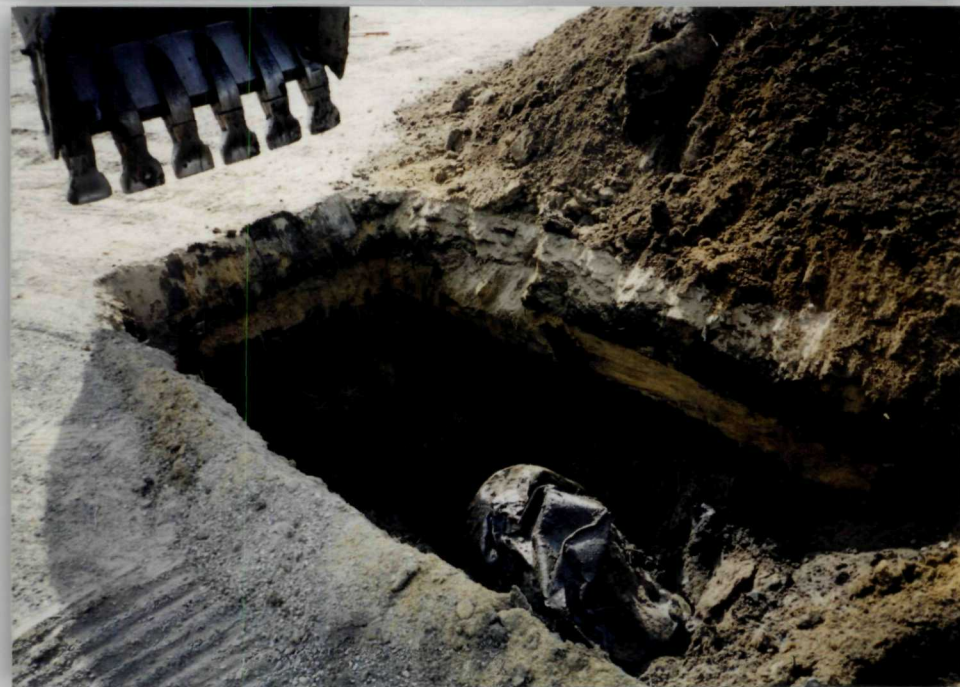
Photo: 21

Description: Looking southeast into Trench No. 9 located about 100 feet northwest of SA01. Drums are about 3 feet below ground surface. Open drums are leaking clear liquid into the excavation. Rubber material is oozing from one of the drums.

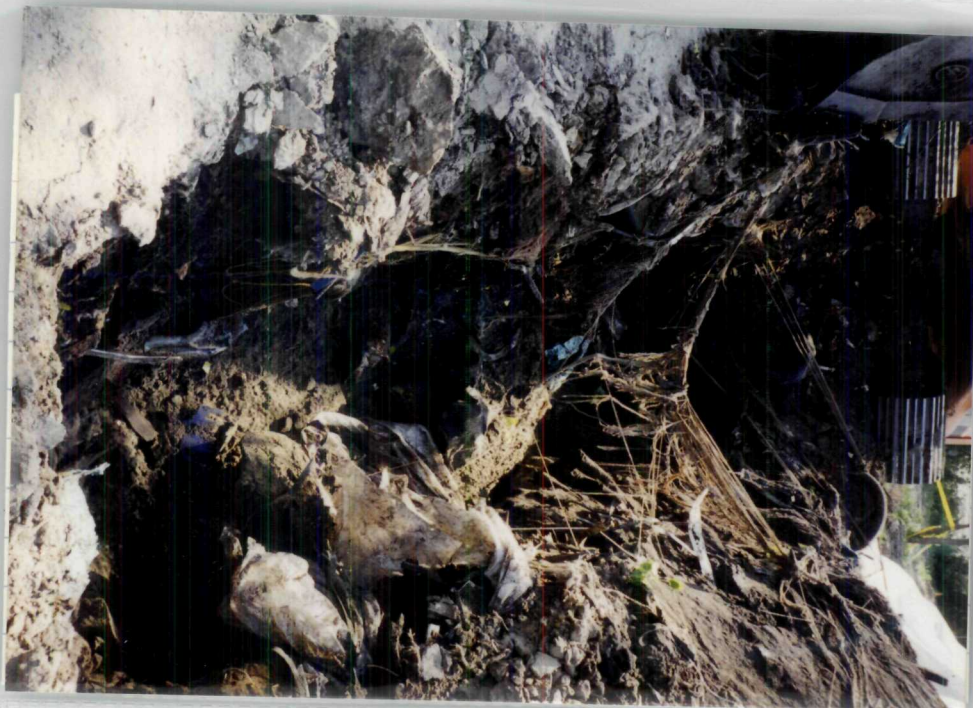
Photo: 24

Description: Looking west at Trench No. 10 located about 200 feet northwest of SA01. Hit drums but no liquid and a lot of soil and debris. Drums are located at about 6 feet below ground surface

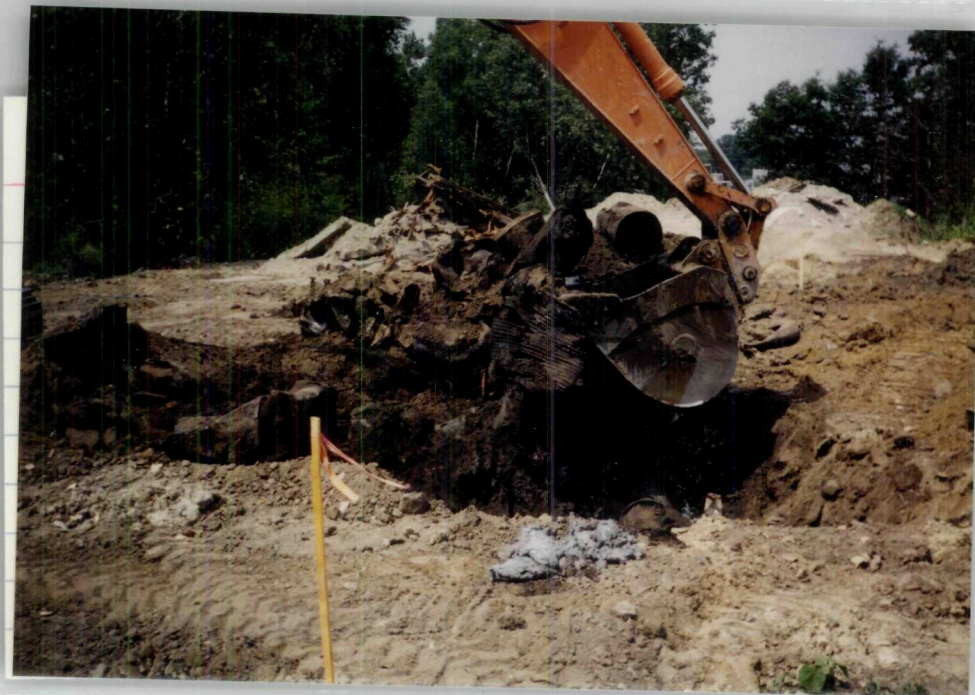
Photo: 23

Description: Looking north at SA04 pit. Large amount of broken drums. Grey gelatinous material in foreground.
